**Flood Control Project Maintenance
Levee Inspections**

Fall 2015 Levee Maintenance Deficiency Summary Report

Sacramento River Basin

Sutter Maintenance Yard Maintenance Area 0001

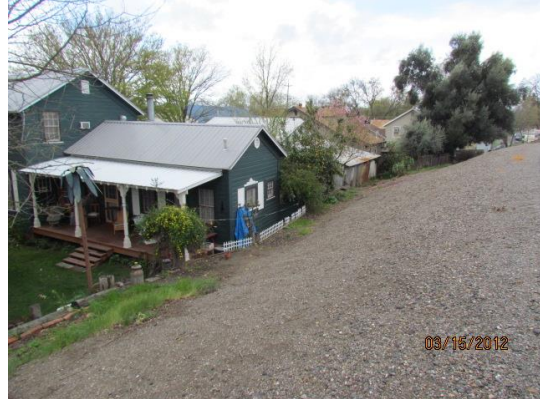
Photo 1 of 1 : FA_2015_MA0001_297_2_20150910_00003.jpg

LM Start	0.04	Rating **	U	Issue No.	2
LM End	0.23	Issue Type +	En	Location *	LS
Category	Earthen Levee			GPS Latitude/Longitude	
				Start	End
Item	Encroachments			39.213988 °	39.215198 °
				-122.001537 °	-122.004775 °
DWR ID	DWR_MA0001_01_s _ 2012_2				
Action/Comments					
Building

View of the building along the L/S toe.

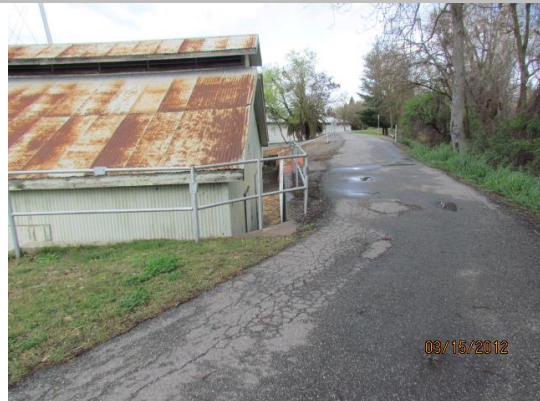
Photo 1 of 1 : FA_2015_MA0001_297_7_20150910_00006.jpg

LM Start	0.67	Rating **	U	Issue No.	7
LM End	0.70	Issue Type +	En	Location *	LS
Category	Earthen Levee			GPS Latitude/Longitude	
				Start	End
Item	Encroachments			39.216533 °	39.216680 °
				-122.012512 °	-122.012907 °
DWR ID	DWR_MA0001_01_s _ 2012_7				
Action/Comments					
Building

View of the buildings along the L/S toe.

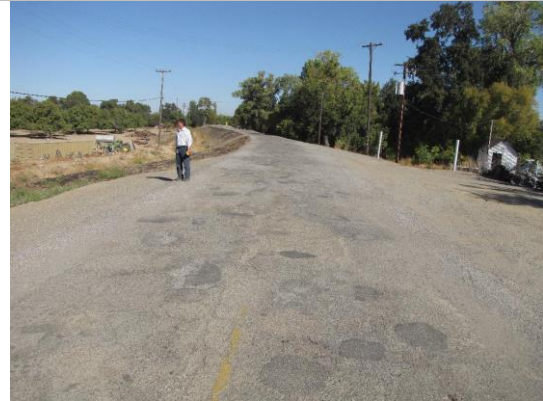
Photo 3 of 3 : UCIP_FA_2015_4790.jpg

Inspector Comments: FS_ID:44590
DS_ID:16431
EP_NO: 9481
FS_HLM: 1.197
Repair Type: Non-Urgent
Crossing Status: Found
UCIP Comments: 4/20/2015 Same as last inspection. No repairs have been made yet. Need pressure test/video inspection to determine integrity of pipe wall. WS-woody debris scattered along slope & bank. Erosion on bank near ditch. LS-discharge pipe heavily corroded & CMP section missing. This crossing was listed in the USACE Periodic Inspections as ID# USACE_CESPK_MA1C_2010_p_0097 for debris & encroachment within 15 feet. 7/18/2013 LS outlet was underwater and could not be inspected but nothing looks to have been changed. 12/17/2013 Same as last inspection. 6/18/2014 Same as last inspection.
FIELD_STRUCT_DESC: 36-inch corrugated metal pipe (CMP) through the levee, slide gate on the waterward slope. (ABO No. 9481-1974, Roberts Ditch Irrigation Company) Crossing penetrates the levee at an angle. Other appurtenances located at this crossing include slant pump, concrete distribution box and shed structure located 100 feet northeast from levee crossing. Flow is carried from concrete distribution box to slide gate via concrete lined ditch. This entry matches the Drainage and Irrigation Structure referenced in O&M manual (Station 63+53).

Overview of levee crown at crossing looking U/S.

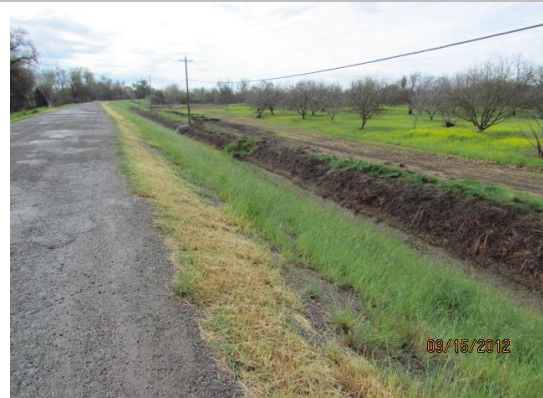
Photo 1 of 1 : FA_2015_MA0001_297_6_20150910_00005.jpg

LM Start	1.20	Rating **	U	Issue No.	6
LM End	1.34	Issue Type +	En	Location *	LS
Category	Earthen Levee			GPS Latitude/Longitude	
				Start	End
Item	Encroachments			39.222119 °	39.224063 °
				-122.015747 °	-122.016080 °
DWR ID	DWR_MA0001_01_s_2012_6

Ditch

View of ag. ditch along the L/S toe.

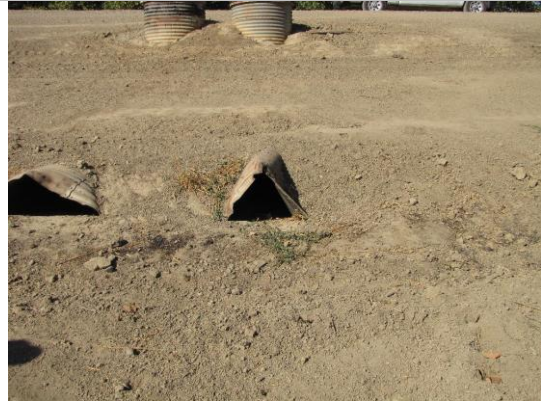
Photo 3 of 3 : UCIP_FA_2015_4821.jpg

Action/Comments					
Inspector Comments: FS_ID:44593 DS_ID:17565 EP_NO: 9487 FS_HLM: 1.961 Repair Type: Non-Urgent Crossing Status: Found UCIP Comments: 4/20/2015 WS pipe end plugged about 50% by soil.WS-remove dirt and debris in riser. Outlet deformed and blocked over 50%. Burrow activity near outlet on waterward slope. Debris around concrete section on landward side. This crossing was listed in the USACE Periodic Inspections as ID# USACE_CESPK_MA1C_2010_p_0116 for crossing outlet deformed and clogged with dirt.7/18/2013 WS pipe end has been reformed but is still partially blocked with dirt and debris.12/17/2013 Same as last inspection.6/18/2014 Same as last inspection. FIELD_STRUCT_DESC: 2 of 2: 36-inch corrugated metal pipe (CMP) through the levee. Slide gates in CMP riser on the waterward slope. (ABO No. 9487-1974, Jimeno Rancho) This entry matches the Drainage and Irrigation Structure referenced in O&M manual (Station 103+18). FS Date: 04/21/2015

CMP pipe outlet deformed with over 50 percent blockage.

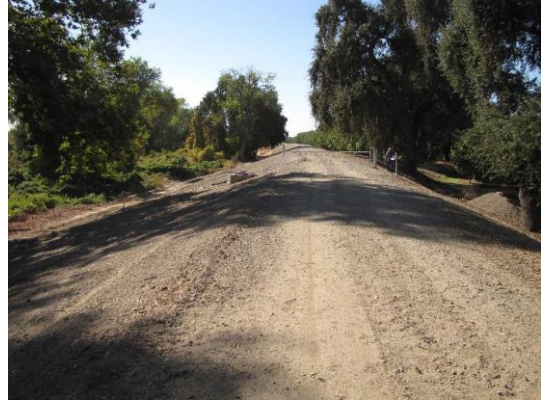
Photo 2 of 3 : UCIP_FA_2015_3731.jpg

Action/Comments					
Inspector Comments: FS_ID:44594 DS_ID:16429 EP_NO: 9472 FS_HLM: 2.281 Repair Type: Non-Urgent Crossing Status: Found UCIP Comments: 4/20/2015 Same as last inspection. Remove debris from riser. Landward inlet is blocked by over 50%. This crossing was listed in the USACE Periodic Inspections as ID# USACE_CESPK_MA1C_2010_p_0128 for sediment build up at inlet (landward side) and debris inside riser. 7/18/2013 Same as last inspection. 12/17/2013 Same as last inspection. 6/18/2014 Same as last inspection. FIELD_STRUCT_DESC: 54-inch corrugated metal drain pipe through the levee. Slide gate in CMP riser on the waterward slope. 48-inch corrugated metal pipe at landward slope. This crossing crosses the levee at an angle. (ABO No. 9472-1974, Ballard) This entry matches the Drainage and Irrigation Structure referenced in O&M manual (Station 120+00) dated 1955. FS Date: 04/21/2015

View of levee crown looking downstream at crossing. CMP riser located on waterward shoulder.

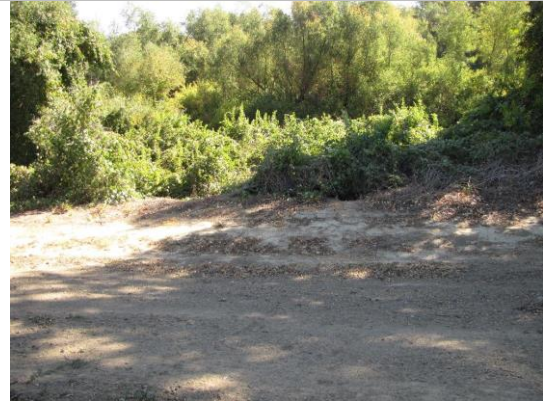
Photo 1 of 3 : UCIP_FA_2015_3733.jpg

Inspector Comments: FS_ID:44595
 DS_ID:16428
 EP_NO: 9467
 FS_HLM: 2.297
 Repair Type: Non-Urgent
 Crossing Status: Found
 UCIP Comments: 4/20/2015 Same as last inspection. Only riser visible. Debris and sediment blocking gate. Gate inside riser is buried and non-functional. If crossing is abandoned, owner needs to properly abandon. This crossing was listed in the USACE Periodic Inspections as ID# USACE_CESPK_MA1C_2010_p_0132 no culvert through the levee is visible here. 7/18/2013 Same as last inspection. 12/17/2013 Same as last inspection. 6/18/2014 Same as last inspection.
 FIELD_STRUCT_DESC: 24-inch corrugated metal drain pipe through levee. Slide gate in CMP riser on the waterward slope. (ABO No. 9467-1974, Lovell E. Spurgeon) This entry matches the Drainage and Irrigation Structure referenced in O&M manual (Station 120+60)
 FS Date: 04/21/2015

Unable to locate waterward outlet.

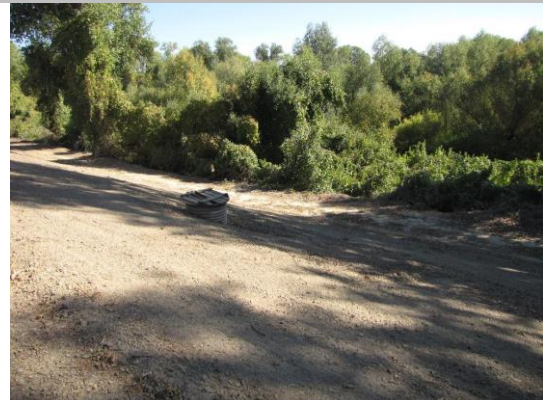
Photo 2 of 3 : UCIP_FA_2015_3734.jpg

View of waterward slope and toe.

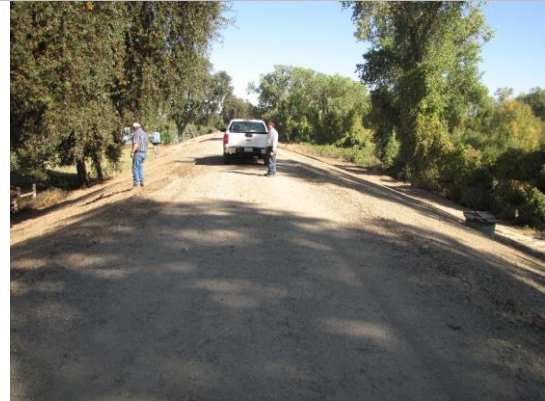
Photo 3 of 3 : UCIP_FA_2015_3735.jpg

LM Start	2.25	Rating **	M	Issue No.	643 (cont)
LM End	2.25	Issue Type +	En	Location *	LS
Category	Supplemental			GPS Latitude/Longitude	
				Start	End
Item	DWR UCIP Field Study			39.236178 °	39.236178 °
				-122.012812 °	-122.012812 °
DWR ID					
Action/Comments					
Inspector Comments: FS_ID:44595					
DS_ID:16428					
EP_NO: 9467					
FS_HLM: 2.297					
Repair Type: Non-Urgent					
Crossing Status: Found

Overview of levee crown looking upstream at crossing.

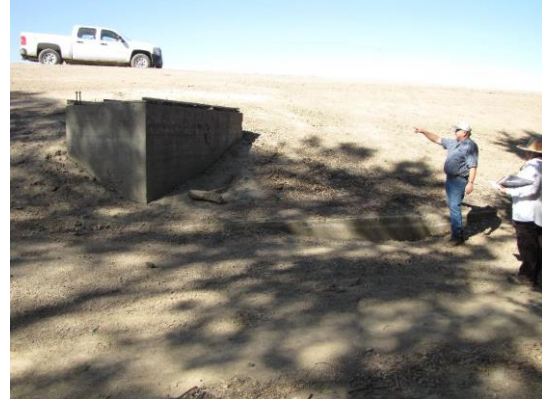
Photo 3 of 3 : UCIP_FA_2015_4929.jpg

UCIP Comments: 4/20/2015 Positive closure device is missing and water cannot be prevented from flowing through pipe during high water. During high water flow goes through levee. Missing positive closure device on waterward side. This structure appears abandoned- slide gates have been removed. Crossing needs to be properly abandoned. This crossing was listed in the USACE Periodic Inspection as ID# USACE_CESPK_MA1C_2010_p_0169 for concrete box partially filled with dirt. 7/18/2013 Same as last inspection. 12/17/2013 Same as last inspection. 6/18/2014 Same as last inspection.

View of concrete distribution box and headwall located on waterward side.

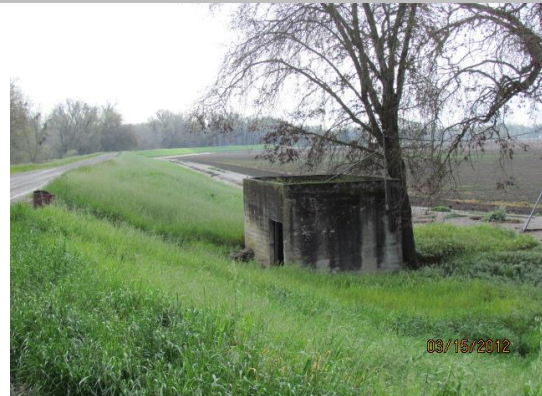
Photo 1 of 1 : FA_2015_MA0001_297_5_20150910_00004.jpg

LM Start	3.05	Rating **	U	Issue No.	5
LM End	3.70	Issue Type +	En	Location *	LS
Category	Earthen Levee			GPS Latitude/Longitude	
				Start	End
Item	Encroachments			39.246822 °	39.256054 °
				-122.008146 °	-122.009808 °
DWR ID	DWR_MA0001_01_s_2012_5				
Action/Comments					
Ditch

View of the ag. ditch & concrete building along the L/S toe.

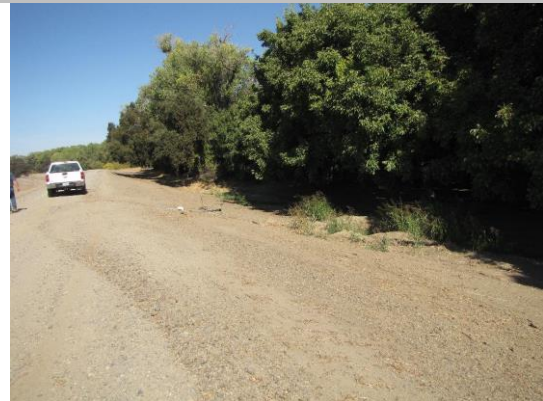
Photo 1 of 3 : UCIP_FA_2015_4967.jpg

LM Start	3.33	Rating **	M	Issue No.	646
LM End	3.33	Issue Type +	En	Location *	WS
Category	Supplemental			GPS Latitude/Longitude	
				Start	End
Item	DWR UCIP Field Study			39.250843 °	39.250843 °
				-122.007992 °	-122.007992 °
DWR ID					
Action/Comments					
Inspector Comments: FS_ID:44599					
DS_ID:16426					
EP_NO: 9490					
FS_HLM: 3.4					
Repair Type: Non-Urgent					
Crossing Status: Found

View of waterward side looking upstream.

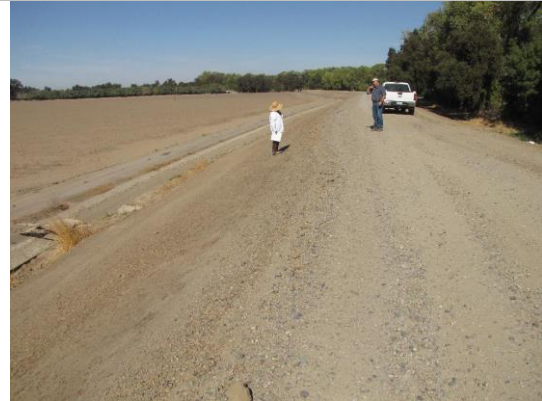
Photo 2 of 3 : UCIP_FA_2015_4968.jpg

View of landward side looking upstream.

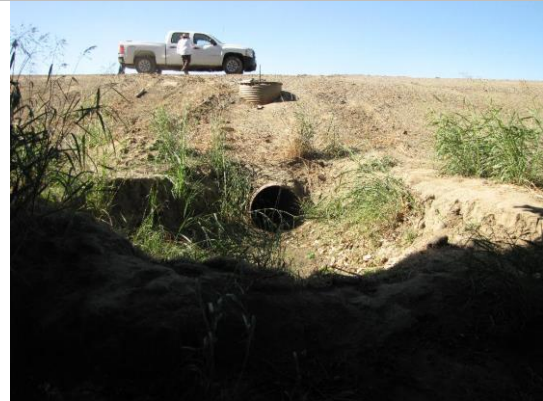
Photo 3 of 3 : UCIP_FA_2015_5080.jpg

View of waterward slope, riser with slide gate, and outlet.

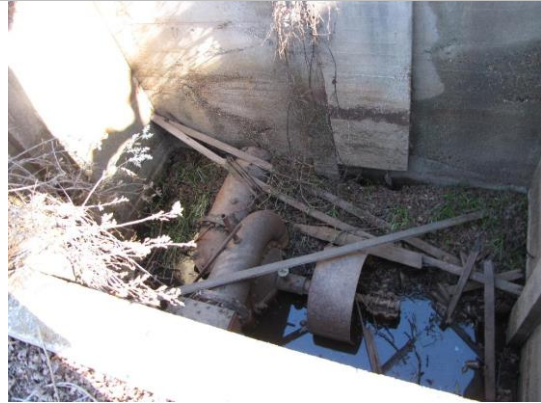
Photo 1 of 3 : UCIP_FA_2015_5081.jpg

LM Start	3.71	Rating **	M	Issue No.	648 (cont)
LM End	3.71	Issue Type +	En	Location *	WS

Debris inside concrete structure located on landward side.

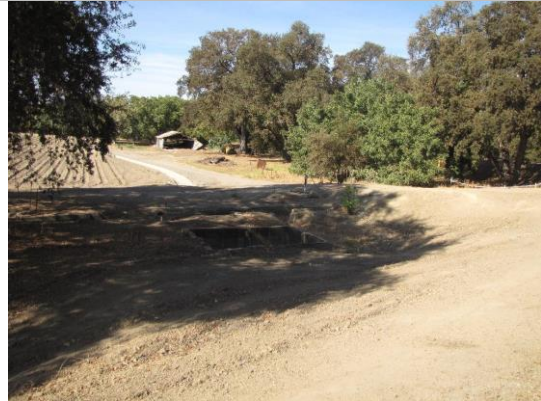
Photo 3 of 3 : UCIP_FA_2015_5083.jpg

LM Start	3.71	Rating **	M	Issue No.	648 (cont)
LM End	3.71	Issue Type +	En	Location *	WS
Category	Supplemental			GPS Latitude/Longitude	
				Start	End
Item	DWR UCIP Field Study			39.256189 °	39.256189 °
				-122.009957 °	-122.009957 °
DWR ID					
Action/Comments					
Inspector Comments: FS_ID:44603					
DS_ID:16424					
EP_NO: 9490					
FS_HLM: 3.794					
Repair Type: Non-Urgent					
Crossing Status: Found

Concrete distribution box located on landward side.

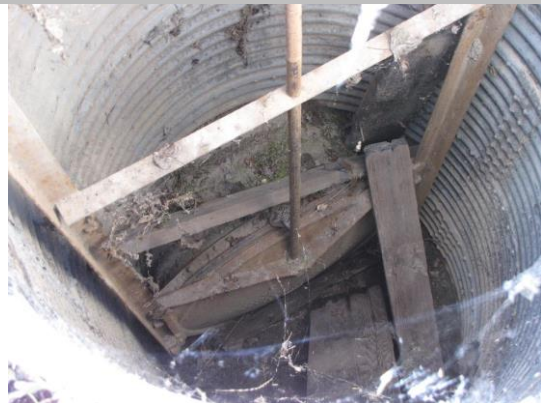
Photo 1 of 3 : UCIP_FA_2015_5084.jpg

LM Start	3.77	Rating **	U	Issue No.	649
LM End	3.77	Issue Type +	En	Location *	WS
Category	Supplemental			GPS Latitude/Longitude	
				Start	End
Item	DWR UCIP Field Study			39.256553 °	39.256553 °
				-122.010912 °	-122.010912 °
DWR ID					
Action/Comments					
Inspector Comments: FS_ID:44604 DS_ID:16423 EP_NO: 9489 FS_HLM: 3.854 Repair Type: Urgent Crossing Status: Found UCIP Comments: 4/20/2015 Same as last inspection.Slide gate wheel handle missing. Clear debris from CMP riser. This crossing was listed in the USACE Periodic Inspection as ID# USACE_CESPK_MA1C_2010_p_0196 for access box contains backfilled (permanently shut) and outlet located on landside has sediment build up.7/18/2013 Same as last inspection.12/17/2013 Same as last inspection.6/18/2014 Same as last inspection. FIELD_STRUCT_DESC: 36-inch corrugated metal pipe through the levee. Slide gate in CMP riser on the waterward slope. 6 foot by 6 foot concrete box on the waterward berm . Additional 12-inch pipe inside concrete distribution box. (ABO No. 9489-1974, Mayfair Farms Inc.) This entry matches the Drainage and Irrigation Structure referenced in O&M manual (Station 198+00). FS Date: 04/22/2015

Inside view of CMP riser located on waterward slope.

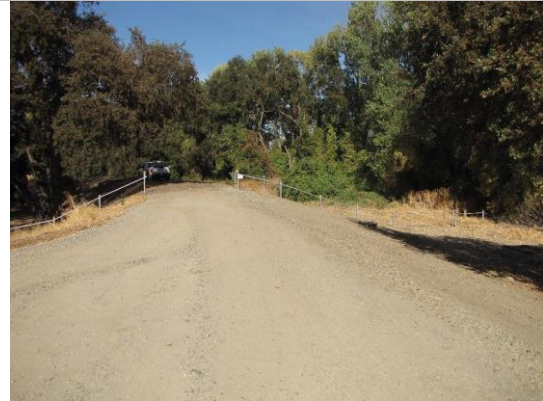
Photo 2 of 3 : UCIP_FA_2015_5085.jpg

Action/Comments					
Inspector Comments: FS_ID:44604 DS_ID:16423 EP_NO: 9489 FS_HLM: 3.854 Repair Type: Urgent Crossing Status: Found UCIP Comments: 4/20/2015 Same as last inspection. Slide gate wheel handle missing. Clear debris from CMP riser. This crossing was listed in the USACE Periodic Inspection as ID# USACE_CESPK_MA1C_2010_p_0196 for access box contains backfilled (permanently shut) and outlet located on landside has sediment build up. 7/18/2013 Same as last inspection. 12/17/2013 Same as last inspection. 6/18/2014 Same as last inspection. FIELD_STRUCT_DESC: 36-inch corrugated metal pipe through the levee. Slide gate in CMP riser on the waterward slope. 6 foot by 6 foot concrete box on the waterward berm . Additional 12-inch pipe inside concrete distribution box. (ABO No. 9489-1974, Mayfair Farms Inc.) This entry matches the Drainage and Irrigation Structure referenced in O&M manual (Station 198+00). FS Date: 04/22/2015

View of crossing looking upstream. Concrete box located on the waterward side.

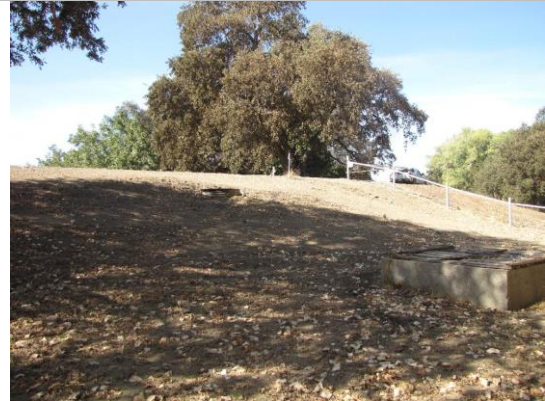
Photo 3 of 3 : UCIP_FA_2015_5086.jpg

Action/Comments					
Inspector Comments: FS_ID:44604 DS_ID:16423 EP_NO: 9489 FS_HLM: 3.854 Repair Type: Urgent Crossing Status: Found UCIP Comments: 4/20/2015 Same as last inspection. Slide gate wheel handle missing. Clear debris from CMP riser. This crossing was listed in the USACE Periodic Inspection as ID# USACE_CESPK_MA1C_2010_p_0196 for access box contains backfilled (permanently shut) and outlet located on landside has sediment build up. 7/18/2013 Same as last inspection. 12/17/2013 Same as last inspection. 6/18/2014 Same as last inspection. FIELD_STRUCT_DESC: 36-inch corrugated metal pipe through the levee. Slide gate in CMP riser on the waterward slope. 6 foot by 6 foot concrete box on the waterward berm . Additional 12-inch pipe inside concrete distribution box. (ABO No. 9489-1974, Mayfair Farms Inc.) This entry matches the Drainage and Irrigation Structure referenced in O&M manual (Station 198+00). FS Date: 04/22/2015

View of concrete distribution box and CMP riser located on waterward side.

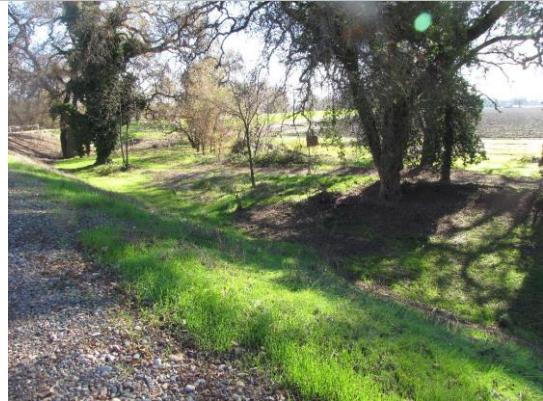
Photo 1 of 3 : UCIP_FA_2015_5087.jpg

LM Start	3.79	Rating **	M	Issue No.	650
LM End	3.79	Issue Type +	En	Location *	WS
Category	Supplemental			GPS Latitude/Longitude	
				Start	End
Item	DWR UCIP Field Study			39.256606 °	39.256606 °
				-122.011115 °	-122.011115 °
DWR ID					
Action/Comments					
Inspector Comments: FS_ID:44605 DS_ID:17659 EP_NO: N/A FS_HLM: 3.866 Repair Type: Non-Urgent Crossing Status: Indicator Found UCIP Comments: 4/20/2015 Same as last inspection.USA flag markers show some type of alignment on LS. Unable to determine if crossing still exists at this location.7/18/2013 Same as last inspection.12/17/2013 Same as last inspection.6/18/2014 Same as last inspection. FIELD_STRUCT_DESC: 18 inch steel pipe through the levee at an unknown depth. Automatic drainage gate on the outlet end of the pipe. This entry matches the Drainage and Irrigation Structure referenced in O&M manual (Station 150+20). (USACE, 1955) FS Date: 04/22/2015

View of landward side.

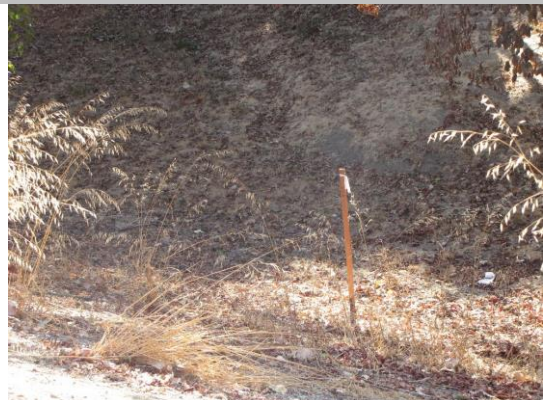
Photo 2 of 3 : UCIP_FA_2015_5088.jpg

Marker on landward toe.

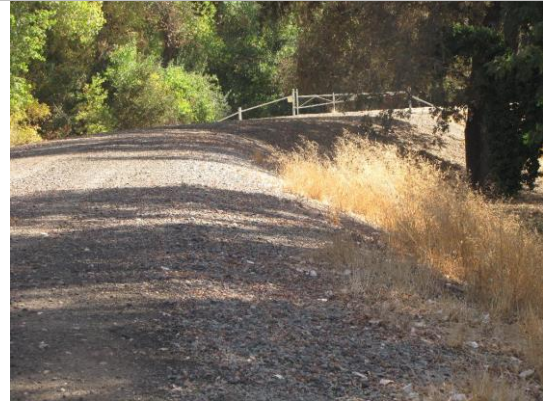
Photo 3 of 3 : UCIP_FA_2015_5089.jpg

LM Start	3.79	Rating **	M	Issue No.	650 (cont)
LM End	3.79	Issue Type +	En	Location *	WS
Category	Supplemental			GPS Latitude/Longitude	
				Start	End
Item	DWR UCIP Field Study			39.256606 °	39.256606 °
				-122.011115 °	-122.011115 °
DWR ID					
Action/Comments					
Inspector Comments: FS_ID:44605					
DS_ID:17659					
EP_NO: N/A					
FS_HLM: 3.866					
Repair Type: Non-Urgent					
Crossing Status: Indicator Found

Levee crown looking downstream. No appurtenances visible on levee crown or slope.

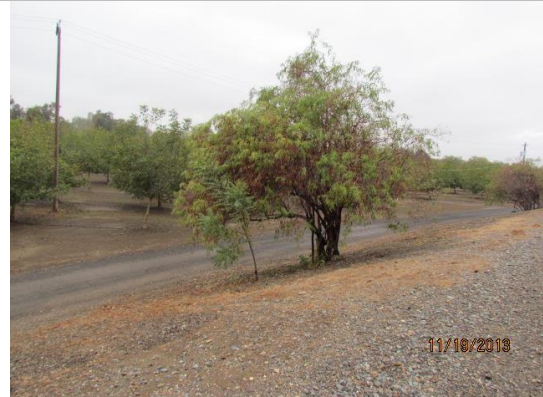
Photo 1 of 1 : FA_2015_MA0001_297_50_20150910_00015.jpg

LM Start	3.88	Rating **	M	Issue No.	50
LM End	3.88	Issue Type +	Ma	Location *	LS
Category	Earthen Levee			GPS Latitude/Longitude	
				Start	End
Item	Vegetation			39.257125 °	39.257125 °
				-122.012648 °	-122.012648 °
DWR ID	DWR_MA0001_01_f_2013_50				
Action/Comments					
Elderberries are blocking visibility and flood fight capability.

View of the elderberry on the landside slope.

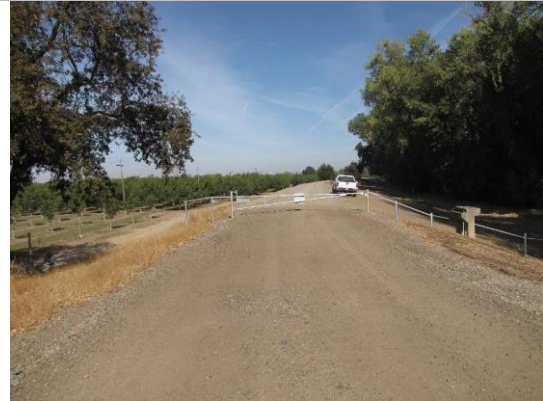
Photo 1 of 3 : UCIP_FA_2015_5090.jpg

Action/Comments					
Inspector Comments: FS_ID:44606					
DS_ID:16422					
EP_NO: N/A					
FS_HLM: 4.035					
Repair Type: Non-Urgent					
Crossing Status: Found					
UCIP Comments: 4/20/2015 Debris is still blocking gate. Appears to be an abandoned crossing. WS-wheel to operate slide gate missing, walkway has been removed; burrow activity near structure; debris in concrete distribution box WS blocking gate. This crossing was listed in the USACE Periodic Inspection as ID#					
USACE_CESPK_MA1C_2010_p_0207 the wheel to operate sluice gate missing.7/18/2013 Wheel to operate slide gate has been replaced but gate is still blocked by debris.12/17/2013 Same as last inspection.6/18/2014 Same as last inspection.					
FIELD_STRUCT_DESC: 24-inch pipe through the levee. Walkway to slide gate on waterward end. Walkway has been removed. Flap gate in concrete distribution box at the landward toe. (ABO - Wilcox)

View of levee crown looking upstream at crossing.

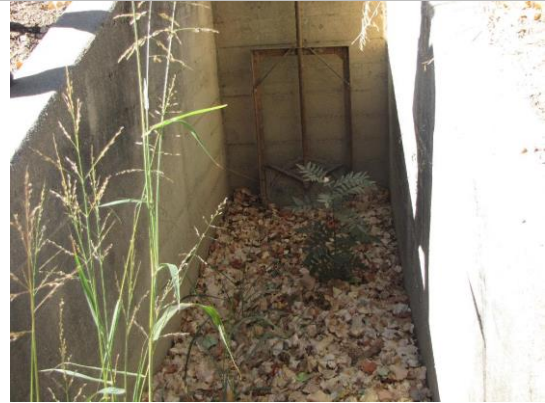
Photo 2 of 3 : UCIP_FA_2015_5091.jpg

Inspector Comments: FS_ID:44606
 DS_ID:16422
 EP_NO: N/A
 FS_HLM: 4.035
 Repair Type: Non-Urgent
 Crossing Status: Found
 UCIP Comments: 4/20/2015 Debris is still blocking gate. Appears to be an abandoned crossing. WS-wheel to operate slide gate missing, walkway has been removed; burrow activity near structure; debris in concrete distribution box WS blocking gate. This crossing was listed in the USACE Periodic Inspection as ID# USACE_CESPK_MA1C_2010_p_0207 the wheel to operate sluice gate missing. 7/18/2013 Wheel to operate slide gate has been replaced but gate is still blocked by debris. 12/17/2013 Same as last inspection. 6/18/2014 Same as last inspection.
 FIELD_STRUCT_DESC: 24-inch pipe through the levee. Walkway to slide gate on waterward end. Walkway has been removed. Flap gate in concrete distribution box at the landward toe. (ABO - Wilcox)
 FS Date: 04/22/2015

View of slide gate located on waterward side.

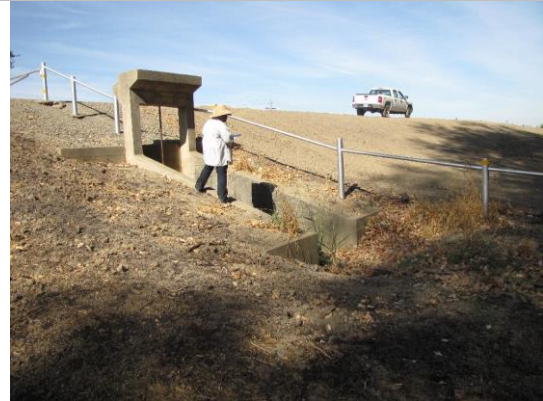
Photo 3 of 3 : UCIP_FA_2015_5131.jpg

Action/Comments					
Inspector Comments: FS_ID:44606					
DS_ID:16422					
EP_NO: N/A					
FS_HLM: 4.035					
Repair Type: Non-Urgent					
Crossing Status: Found					
UCIP Comments: 4/20/2015 Debris is still blocking gate. Appears to be an abandoned crossing. WS-wheel to operate slide gate missing, walkway has been removed; burrow activity near structure; debris in concrete distribution box WS blocking gate. This crossing was listed in the USACE Periodic Inspection as ID#					
USACE_CESPK_MA1C_2010_p_0207 the wheel to operate sluice gate missing.7/18/2013 Wheel to operate slide gate has been replaced but gate is still blocked by debris.12/17/2013 Same as last inspection.6/18/2014 Same as last inspection.					
FIELD_STRUCT_DESC: 24-inch pipe through the levee. Walkway to slide gate on waterward end. Walkway has been removed. Flap gate in concrete distribution box at the landward toe. (ABO - Wilcox)

View of waterward slope with concrete structure.

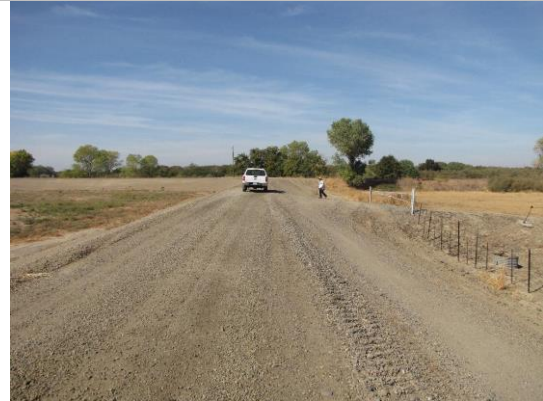
Photo 1 of 3 : UCIP_FA_2015_5132.jpg

Action/Comments					
Inspector Comments: FS_ID:44607 DS_ID:16421 EP_NO: 9475 FS_HLM: 4.749 Repair Type: Non-Urgent Crossing Status: Found UCIP Comments: 4/20/2015 Same as last inspection. Burrow activity; limited visibility of this crossing only on WS riser. This crossing was listed in the USACE Periodic Inspection as ID# USACE_CESPK_MA1C_2010_p_0207 the wheel to operate sluice gate missing. Issue addressed wheel to slide gate has been installed. 7/18/2013 Same as last inspection. 12/17/2013 Same as last inspection. 6/18/2014 Same as last inspection. FIELD_STRUCT_DESC: 30-inch corrugated metal pipe through the levee, 16.1 feet below the crown. Slide gate on the waterward end. (ABO No. 9475-1974, Mattie B. Zumwalt Co.) This entry matches the Drainage and Irrigation Structure referenced in O&M manual (Station 247+86). FS Date: 04/22/2015

Overview of levee crown looking upstream at crossing.

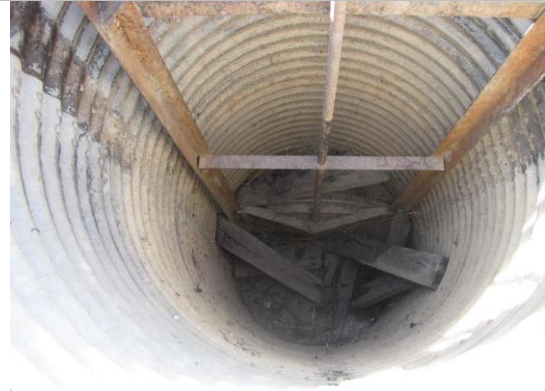
Photo 2 of 3 : UCIP_FA_2015_5133.jpg

Inspector Comments: FS_ID:44607
 DS_ID:16421
 EP_NO: 9475
 FS_HLM: 4.749
 Repair Type: Non-Urgent
 Crossing Status: Found
 UCIP Comments: 4/20/2015 Same as last inspection. Burrow activity; limited visibility of this crossing only on WS riser. This crossing was listed in the USACE Periodic Inspection as ID# USACE_CESPK_MA1C_2010_p_0207 the wheel to operate sluice gate missing. Issue addressed wheel to slide gate has been installed. 7/18/2013 Same as last inspection. 12/17/2013 Same as last inspection. 6/18/2014 Same as last inspection.
 FIELD_STRUCT_DESC: 30-inch corrugated metal pipe through the levee, 16.1 feet below the crown. Slide gate on the waterward end. (ABO No. 9475-1974, Mattie B. Zumwalt Co.) This entry matches the Drainage and Irrigation Structure referenced in O&M manual (Station 247+86).
 FS Date: 04/22/2015

Woody debris inside riser blocking gate.

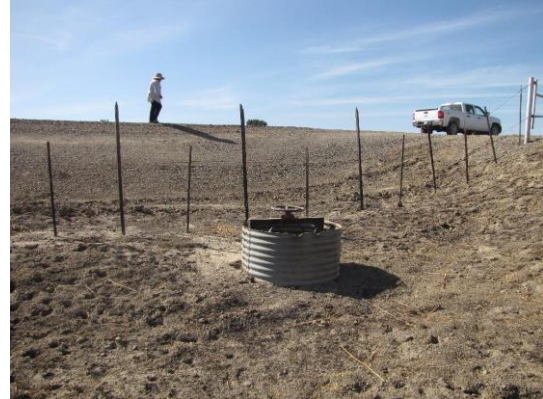
Photo 3 of 3 : UCIP_FA_2015_5134.jpg

Item	DWR UCIP Field Study			39.266435 °	39.266435 °	
				-122.010943 °	-122.010943 °	
DWR ID						
Action/Comments						
Inspector Comments: FS_ID:44607 DS_ID:16421 EP_NO: 9475 FS_HLM: 4.749 Repair Type: Non-Urgent Crossing Status: Found UCIP Comments: 4/20/2015 Same as last inspection.Burrow activity; limited visibility of this crossing only on WS riser. This crossing was listed in the USACE Periodic Inspection as ID# USACE_CESPK_MA1C_2010_p_0207 the wheel to operate sluice gate missing. Issue addressed wheel to slide gate has been installed.7/18/2013 Same as last inspection.12/17/2013 Same as last inspection.6/18/2014 Same as last inspection. FIELD_STRUCT_DESC: 30-inch corrugated metal pipe through the levee, 16.1 feet below the crown. Slide gate on the waterward end. (ABO No. 9475-1974, Mattie B. Zumwalt Co.) This entry matches the Drainage and Irrigation Structure referenced in O&M manual (Station 247+86). FS Date: 04/22/2015

Riser with slide gate located on waterward toe.

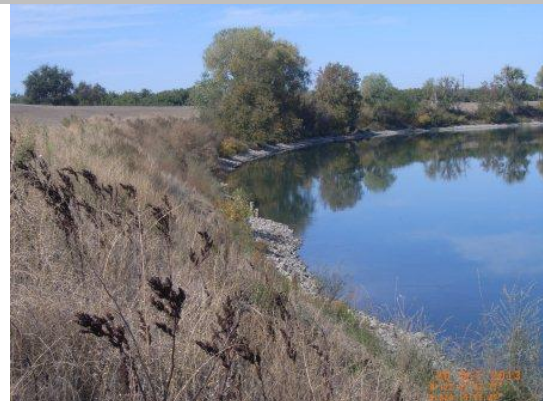
Photo 1 of 1 : USACE2013A_SAC_151-0_R_6.jpg

LM Start	4.86	Rating **	M	Issue No.	3
LM End	5.26	Issue Type +	Ma	Location *	WS
Category	Supplemental			GPS Latitude/Longitude	
				Start	End
Item	2015 USACE Erosion Survey, DRAFT			39.265730 °	39.266315 °
				-122.014925 °	-122.020682 °
DWR ID					
Action/Comments					
Inspector Comments: 2009 - Slump in the middle of the section has left a vertical section on the bank. 2010 - Old cobble site unraveling, site extended downstream. 2015: Last observed in 2013. [2015 Site ID: SAC_151-0_R]

USACE 2013 Photo #1

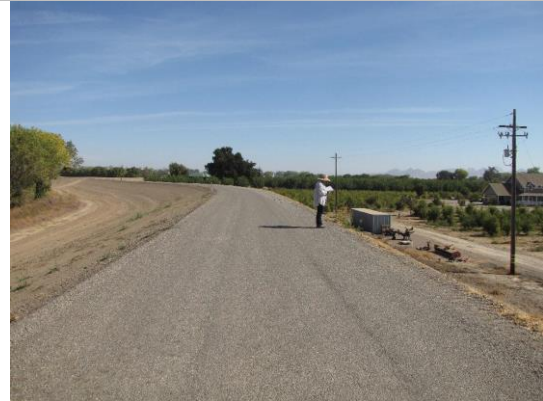
Photo 1 of 3 : UCIP_FA_2015_4386.jpg

Inspector Comments: FS_ID:44608
 DS_ID:16420
 EP_NO: 4903
 FS_HLM: 5.075
 Repair Type: Non-Urgent
 Crossing Status: Found
 UCIP Comments: 4/20/2015 Suspect that pump on LS is a well pump and has nothing to do with this crossing. Unable to locate siphon breaker, pump on LS; unable to tell if pump system is part of appurtenances. This crossing was listed in the USACE Periodic Inspection as ID# USACE_CESPK_MA1C_2010_p_0233 for utility pole and 8 inch steel riser located on landward toe. 7/18/2013 Same as last inspection. 12/17/2013 Same as last inspection. 6/18/2014 Same as last inspection.
 FIELD_STRUCT_DESC: 12-inch irrigation pipe through the levee. Siphon breaker in 24-inch CMP riser on the landward shoulder. 3-inch electrical conduit through the levee. (Permit No. 4903, A-1966, Zumwalt)
 FS Date: 04/22/2015

View of levee crown looking downstream at crossing.

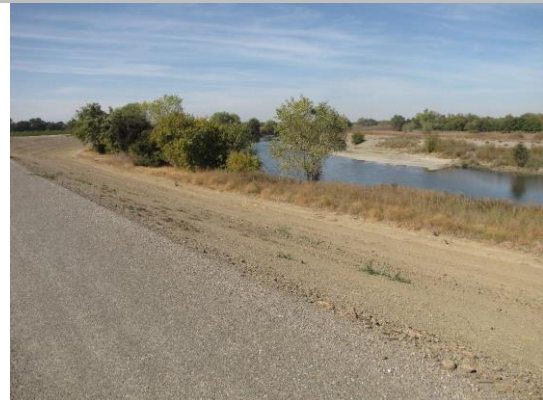
Photo 2 of 3 : UCIP_FA_2015_5135.jpg

View of waterward side-no visible appurtenances associated with structure.

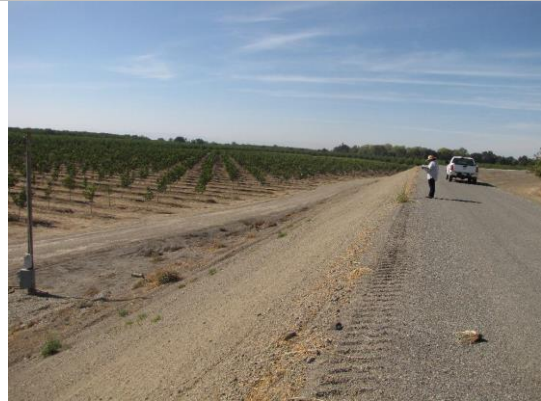
Photo 3 of 3 : UCIP_FA_2015_5136.jpg

LM Start	4.97	Rating **	M	Issue No.	653 (cont)
LM End	4.97	Issue Type +	En	Location *	WS
Category	Supplemental			GPS Latitude/Longitude	
				Start	End
Item	DWR UCIP Field Study			39.264924 °	39.264924 °
				-122.015887 °	-122.015887 °
DWR ID					
Action/Comments					
Inspector Comments: FS_ID:44608					
DS_ID:16420					
EP_NO: 4903					
FS_HLM: 5.075					
Repair Type: Non-Urgent					
Crossing Status: Found

View of levee crown looking upstream at crossing.

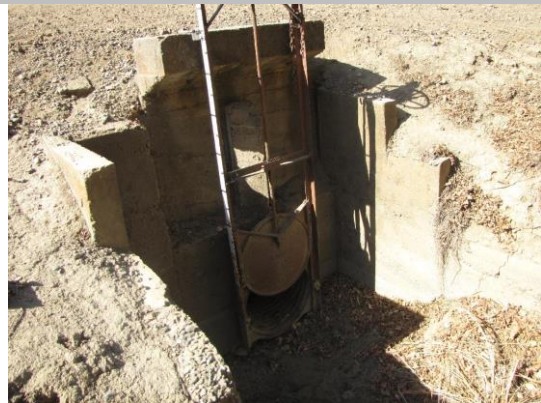
Photo 1 of 3 : UCIP_FA_2015_5251.jpg

LM Start	5.72	Rating **	M	Issue No.	654
LM End	5.72	Issue Type +	En	Location *	WS
Category	Supplemental			GPS Latitude/Longitude	
				Start	End
Item	DWR UCIP Field Study			39.272069 °	39.272069 °
				-122.023240 °	-122.023240 °
DWR ID					
Action/Comments					
Inspector Comments: FS_ID:44624 DS_ID:17569 EP_NO: 9476 FS_HLM: 5.844 Repair Type: Non-Urgent Crossing Status: Found UCIP Comments: 4/20/2015 WS entry still blocked and wingwalls still cracked.blocked, no entry on WS. This crossing was listed in the USACE Periodic Inspection as ID# USACE_CESPK_MA1C_2010_p_0247 for u/s and d/s wing wall shows some cracking and tilting.7/18/2013 Same as last inspection.12/17/2013 Same as last inspection.6/18/2014 Same as last inspection. FIELD_STRUCT_DESC: 2 of 2: 36-inch corrugated metal pipe (15 feet long) and concrete box culvert through the levee. Slide gate located on waterward. (ABO No. 9476-1974, Howard C. & Nadine M. Ohliger) FS Date: 04/22/2015

Headwall and slide gate located on waterward side.

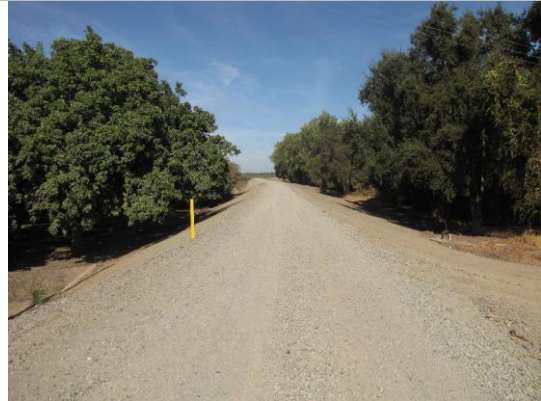
Photo 2 of 3 : UCIP_FA_2015_5252.jpg

Action/Comments					
Inspector Comments: FS_ID:44624 DS_ID:17569 EP_NO: 9476 FS_HLM: 5.844 Repair Type: Non-Urgent Crossing Status: Found UCIP Comments: 4/20/2015 WS entry still blocked and wingwalls still cracked.blocked, no entry on WS. This crossing was listed in the USACE Periodic Inspection as ID# USACE_CESPK_MA1C_2010_p_0247 for u/s and d/s wing wall shows some cracking and tilting.7/18/2013 Same as last inspection.12/17/2013 Same as last inspection.6/18/2014 Same as last inspection. FIELD_STRUCT_DESC: 2 of 2: 36-inch corrugated metal pipe (15 feet long) and concrete box culvert through the levee. Slide gate located on waterward. (ABO No. 9476-1974, Howard C. & Nadine M. Ohliger) FS Date: 04/22/2015

View of levee crown looking upstream at crossing.

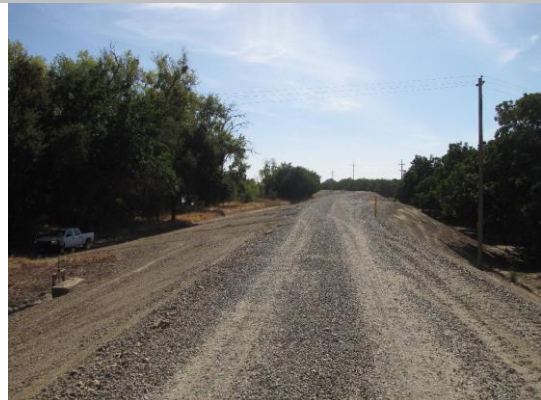
Photo 3 of 3 : UCIP_FA_2015_5253.jpg

View of levee crown looking downstream at crossing.

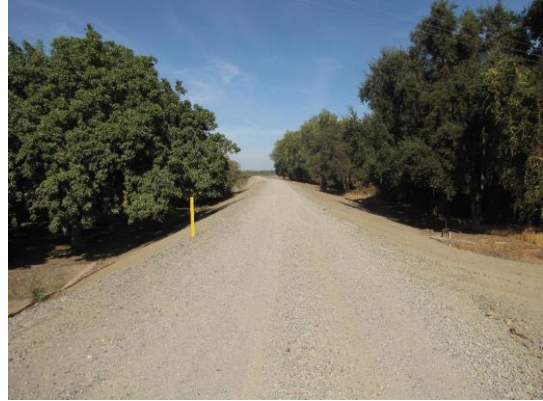
Photo 1 of 3 : UCIP_FA_2015_4387.jpg

LM Start	5.72	Rating **	M	Issue No.	655
LM End	5.72	Issue Type +	En	Location *	WS
Category	Supplemental			GPS Latitude/Longitude	
				Start	End
Item	DWR UCIP Field Study			39.272069 °	39.272069 °
				-122.023240 °	-122.023240 °
DWR ID					
Action/Comments					
Inspector Comments: FS_ID:44623					
DS_ID:16419					
EP_NO: 9476					
FS_HLM: 5.842					
Repair Type: Non-Urgent					
Crossing Status: Found

View of crossing looking upstream at crossing.

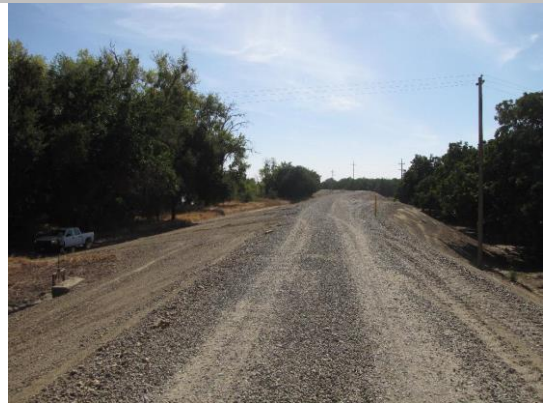
Photo 2 of 3 : UCIP_FA_2015_5249.jpg

Overview of levee crown looking downstream at crossing.

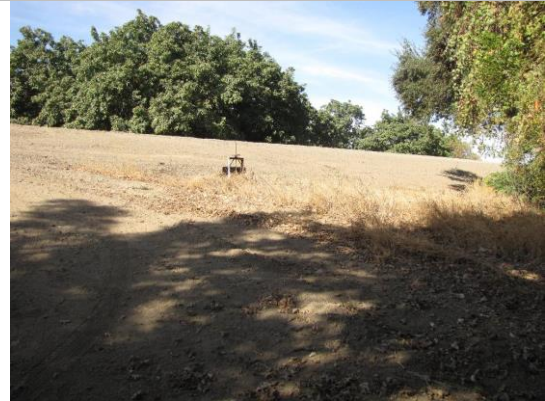
Photo 3 of 3 : UCIP_FA_2015_5250.jpg

LM Start	5.72	Rating **	M	Issue No.	655 (cont)
LM End	5.72	Issue Type +	En	Location *	WS
Category	Supplemental			GPS Latitude/Longitude	
				Start	End
Item	DWR UCIP Field Study			39.272069 °	39.272069 °
				-122.023240 °	-122.023240 °
DWR ID					
Action/Comments					
Inspector Comments: FS_ID:44623					
DS_ID:16419					
EP_NO: 9476					
FS_HLM: 5.842					
Repair Type: Non-Urgent					
Crossing Status: Found

View of waterward slope and access road. Slide gate is second crossing at this location.

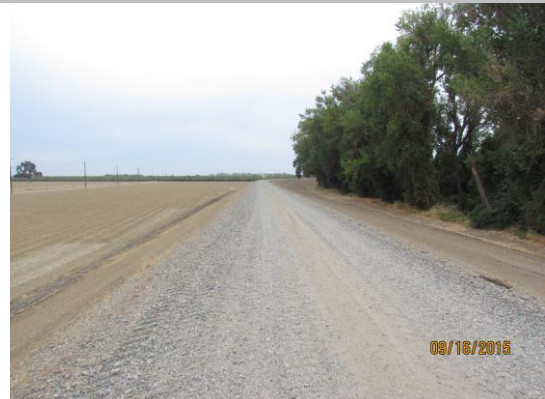
Photo 1 of 1 : FA_2015_MA0001_297_80_20151013_00029.jpg

LM Start	5.82	Rating **	A	Issue No.	80
LM End	5.82	Issue Type +	Ma	Location *	LS
Category	Earthen Levee			GPS Latitude/Longitude	
				Start	End
Item	Vegetation			39.273455 °	39.273455 °
				-122.023323 °	-122.023323 °
DWR ID	DWR_MA0001_01_f_2015_80				
Action/Comments					
Control annual grass and weeds on the levee slopes and easements. Inspector Comments: Sutter Yard burn and dragged both slopes.

View of no vegetation on both slopes.

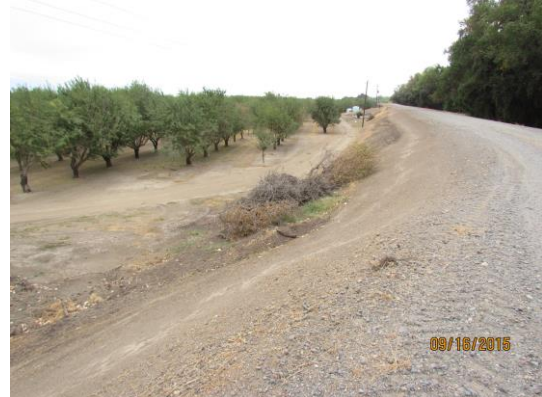
Photo 1 of 1 : FA_2015_MA0001_297_75_20151013_00026.jpg

LM Start	6.12	Rating **	M	Issue No.	75
LM End	6.12	Issue Type +	En	Location *	LS
Category	Earthen Levee			GPS Latitude/Longitude	
				Start	End
Item	Encroachments			39.277733 °	39.277733 °
				-122.022887 °	-122.022887 °
DWR ID	DWR_MA0001_01_f_2015_75				
Action/Comments					
Prunings

View of the prunings along the landside toe.

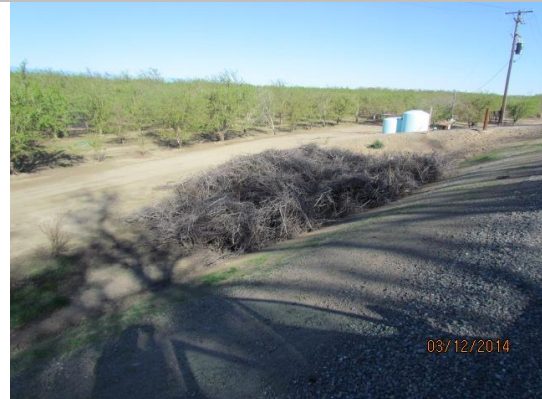
Photo 1 of 1 : FA_2015_MA0001_297_76_20150910_00019.jpg

LM Start	6.20	Rating **	M	Issue No.	76
LM End	6.20	Issue Type +	En	Location *	LS
Category	Earthen Levee			GPS Latitude/Longitude	
				Start	End
Item	Encroachments			39.278917 °	39.278917 °
				-122.022595 °	-122.022595 °
DWR ID	DWR_MA0001_01_s_2014_76				
Action/Comments					
Prunings

View of the prunings along the landside toe.

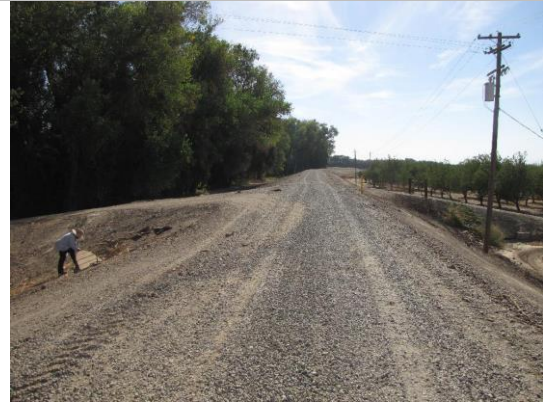
Photo 1 of 3 : UCIP_FA_2015_5254.jpg

Action/Comments					
Inspector Comments: FS_ID:44628					
DS_ID:16446					
EP_NO: 4203					
FS_HLM: 6.374					
Repair Type: Urgent					
Crossing Status: Found					
UCIP Comments: 4/20/2015 5inch pvc is still present blocking slide gate from closing. WS end of pipe has been exposed so there is no way to stop water from flowing through pipe during highwater times.Unauthorized 5 inch PVC pipe running through 36 inch crossing. 5 inch PVC crossing prevents slide gate from closing during high water. Debris and sediment inside riser. This crossing was listed in the USACE Periodic Inspection as ID#					
USACE_CESPK_MA1C_2010_p_0258 for 5 inch PVC pipe running through culvert.7/18/2013 Same as last inspection.12/17/2013					
Same as last inspection.6/23/2014 Same as last inspection. There is no way to stop water from flowing though pipe during high water times.					
FIELD_STRUCT_DESC: 36-inch pipe through the levee. Slide gate in CMP riser on the waterward slope. This entry matches the Drainage and Irrigation Structure referenced in O&M manual (Station 331+31).

Overview of levee crown looking downstream at crossing.

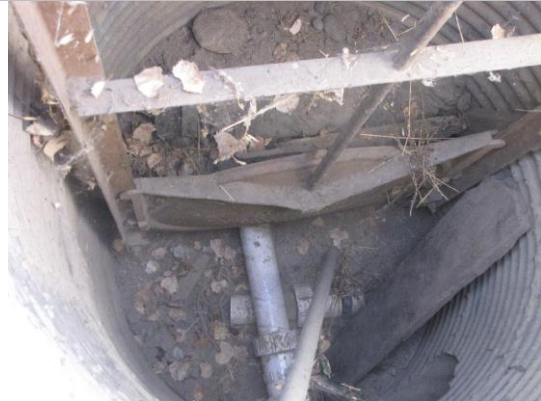
Photo 2 of 3 : UCIP_FA_2015_5255.jpg

Inspector Comments: FS_ID:44628
 DS_ID:16446
 EP_NO: 4203
 FS_HLM: 6.374
 Repair Type: Urgent
 Crossing Status: Found
 UCIP Comments: 4/20/2015 5inch pvc is still present blocking slide gate from closing. WS end of pipe has been exposed so there is no way to stop water from flowing through pipe during highwater times. Unauthorized 5 inch PVC pipe running through 36 inch crossing. 5 inch PVC crossing prevents slide gate from closing during high water. Debris and sediment inside riser. This crossing was listed in the USACE Periodic Inspection as ID#
 USACE_CESPK_MA1C_2010_p_0258 for 5 inch PVC pipe running through culvert. 7/18/2013 Same as last inspection. 12/17/2013 Same as last inspection. 6/23/2014 Same as last inspection. There is no way to stop water from flowing through pipe during high water times.
 FIELD_STRUCT_DESC: 36-inch pipe through the levee. Slide gate in CMP riser on the waterward slope. This entry matches the Drainage and Irrigation Structure referenced in O&M manual (Station 331+31).

Inside view of CMP riser, 5-inch pipe through 36-inch drainage pipe.

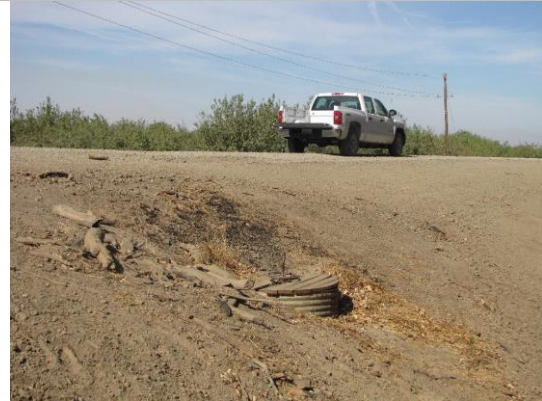
Photo 3 of 3 : UCIP_FA_2015_5256.jpg

Inspector Comments: FS_ID:44628
 DS_ID:16446
 EP_NO: 4203
 FS_HLM: 6.374
 Repair Type: Urgent
 Crossing Status: Found
 UCIP Comments: 4/20/2015 5inch pvc is still present blocking slide gate from closing. WS end of pipe has been exposed so there is no way to stop water from flowing through pipe during highwater times. Unauthorized 5 inch PVC pipe running through 36 inch crossing. 5 inch PVC crossing prevents slide gate from closing during high water. Debris and sediment inside riser. This crossing was listed in the USACE Periodic Inspection as ID#
 USACE_CESPK_MA1C_2010_p_0258 for 5 inch PVC pipe running through culvert. 7/18/2013 Same as last inspection. 12/17/2013 Same as last inspection. 6/23/2014 Same as last inspection. There is no way to stop water from flowing through pipe during high water times.
 FIELD_STRUCT_DESC: 36-inch pipe through the levee. Slide gate in CMP riser on the waterward slope. This entry matches the Drainage and Irrigation Structure referenced in O&M manual (Station 331+31).

CMP riser located on waterward slope.

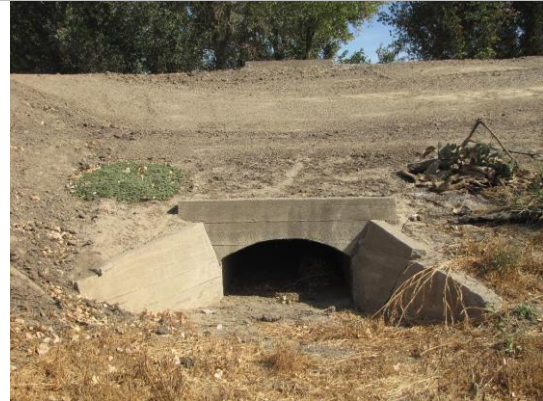
Photo 1 of 3 : UCIP_FA_2015_4701.jpg

Action/Comments					
Inspector Comments: FS_ID:44632 DS_ID:16425 EP_NO: N/A FS_HLM: 6.537 Repair Type: Non-Urgent Crossing Status: Found UCIP Comments: 4/20/2015 Same as last inspection. Need to be properly abandoned concrete structure; plate covers concrete box; Concrete headwall damaged. This crossing was listed in the USACE Periodic Inspection as ID# USACE_CESPK_MA1C_2010_p_0262 for damage to concrete structure (vertical 2 inch wide cracks and spalling visible). 7/18/2013 Same as last inspection. 12/17/2013 Same as last inspection. 6/23/2014 Same as last inspection. FIELD_STRUCT_DESC: Abandoned 72-inch corrugated metal drain (precast concrete) pipe through the levee, blocked on waterward end with 3-foot concrete plug installed in 1980. Slide gate in concrete well on the landward shoulder. Concrete headwall at both toes. This entry matches the Drainage and Irrigation Structure referenced in O&M manual (Station 339+74) FS Date: 04/22/2015

View of structure located in landward side.

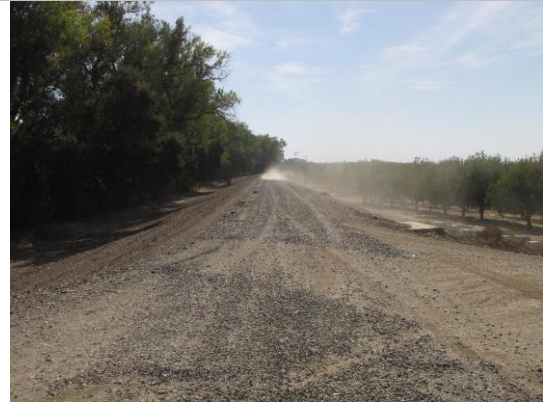
Photo 2 of 3 : UCIP_FA_2015_4702.jpg

Action/Comments					
Inspector Comments: FS_ID:44632 DS_ID:16425 EP_NO: N/A FS_HLM: 6.537 Repair Type: Non-Urgent Crossing Status: Found UCIP Comments: 4/20/2015 Same as last inspection. Need to be properly abandoned concrete structure; plate covers concrete box; Concrete headwall damaged. This crossing was listed in the USACE Periodic Inspection as ID# USACE_CESPK_MA1C_2010_p_0262 for damage to concrete structure (vertical 2 inch wide cracks and spalling visible). 7/18/2013 Same as last inspection. 12/17/2013 Same as last inspection. 6/23/2014 Same as last inspection. FIELD_STRUCT_DESC: Abandoned 72-inch corrugated metal drain (precast concrete) pipe through the levee, blocked on waterward end with 3-foot concrete plug installed in 1980. Slide gate in concrete well on the landward shoulder. Concrete headwall at both toes. This entry matches the Drainage and Irrigation Structure referenced in O&M manual (Station 339+74) FS Date: 04/22/2015

Overview of levee crown looking downstream at crossing.

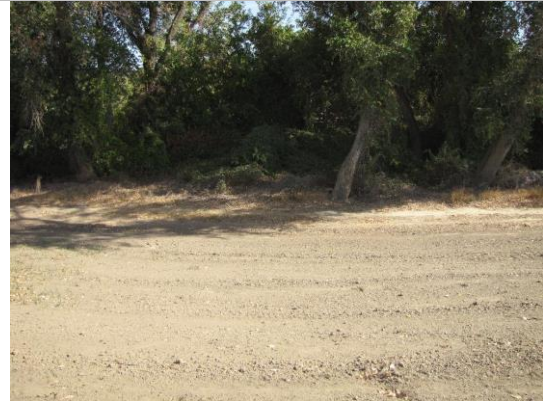
Photo 3 of 3 : UCIP_FA_2015_4703.jpg

Action/Comments					
Inspector Comments: FS_ID:44632 DS_ID:16425 EP_NO: N/A FS_HLM: 6.537 Repair Type: Non-Urgent Crossing Status: Found UCIP Comments: 4/20/2015 Same as last inspection. Need to be properly abandoned concrete structure; plate covers concrete box; Concrete headwall damaged. This crossing was listed in the USACE Periodic Inspection as ID# USACE_CESPK_MA1C_2010_p_0262 for damage to concrete structure (vertical 2 inch wide cracks and spalling visible). 7/18/2013 Same as last inspection. 12/17/2013 Same as last inspection. 6/23/2014 Same as last inspection. FIELD_STRUCT_DESC: Abandoned 72-inch corrugated metal drain (precast concrete) pipe through the levee, blocked on waterward end with 3-foot concrete plug installed in 1980. Slide gate in concrete well on the landward shoulder. Concrete headwall at both toes. This entry matches the Drainage and Irrigation Structure referenced in O&M manual (Station 339+74) FS Date: 04/22/2015

View of waterward side no structure features visible.

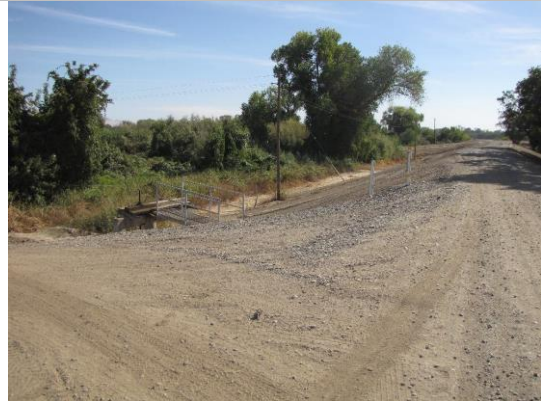
Photo 1 of 3 : UCIP_FA_2015_4704.jpg

LM Start	6.99	Rating **	U	Issue No.	658
LM End	6.99	Issue Type +	En	Location *	LS
Category	Supplemental			GPS Latitude/Longitude	
				Start	End
Item	DWR UCIP Field Study			39.290147 °	39.290147 °
				-122.021525 °	-122.021525 °
DWR ID					
Action/Comments					
Inspector Comments: FS_ID:44644 DS_ID:16427 EP_NO: 9482 FS_HLM: 7.14 Repair Type: Urgent Crossing Status: Found UCIP Comments: 4/20/2015 Same as last inspection. Structure is still buried. Structure is buried and non-operational. This crossing was listed in the USACE Periodic Inspection as ID# USACE_CESPK_MA1C_2010_p_0288 for sluice gate closed and backfilled on WS and full of sediment with wingwall cracked on LS.7/18/2013 Same as last inspection.12/17/2013 Same as last inspection.6/23/2014 Same as last inspection. FIELD_STRUCT_DESC: 1 of 2: 36-inch concrete pipes through the levee. Wooden slide gates on waterward end. Concrete culvert through levee. Sliding metal gate noted in O&M manual. This entry could match the Drainage or Irrigation Structure referenced in the O&M manual (Station 370+90) (USACE-1955)(ABO No. 9482-1974, Elizabeth M. Farnsworth). FS Date: 04/22/2015

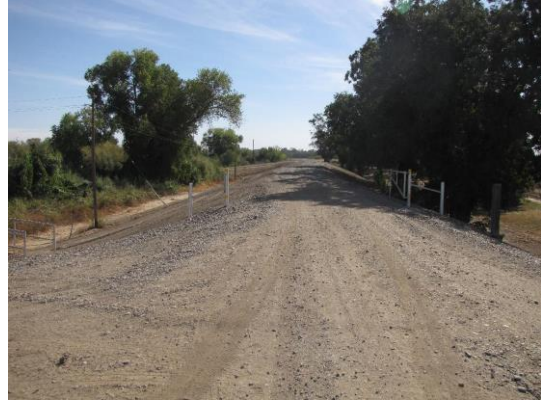
Photo 2 of 3 : UCIP_FA_2015_4705.jpg

LM Start	6.99	Rating **	U	Issue No.	658 (cont)
LM End	6.99	Issue Type +	En	Location *	LS
Category	Supplemental			GPS Latitude/Longitude	
				Start	End
Item	DWR UCIP Field Study			39.290147 °	39.290147 °
				-122.021525 °	-122.021525 °
DWR ID					
Action/Comments					
Inspector Comments: FS_ID:44644 DS_ID:16427 EP_NO: 9482 FS_HLM: 7.14 Repair Type: Urgent Crossing Status: Found UCIP Comments: 4/20/2015 Same as last inspection. Structure is still buried. Structure is buried and non-operational. This crossing was listed in the USACE Periodic Inspection as ID# USACE_CESPK_MA1C_2010_p_0288 for sluice gate closed and backfilled on WS and full of sediment with wingwall cracked on LS. 7/18/2013 Same as last inspection. 12/17/2013 Same as last inspection. 6/23/2014 Same as last inspection. FIELD_STRUCT_DESC: 1 of 2: 36-inch concrete pipes through the levee. Wooden slide gates on waterward end. Concrete culvert through levee. Sliding metal gate noted in O&M manual. This entry could match the Drainage or Irrigation Structure referenced in the O&M manual (Station 370+90) (USACE-1955)(ABO No. 9482-1974, Elizabeth M. Farnsworth). FS Date: 04/22/2015

Overview of levee crown looking downstream at crossing.

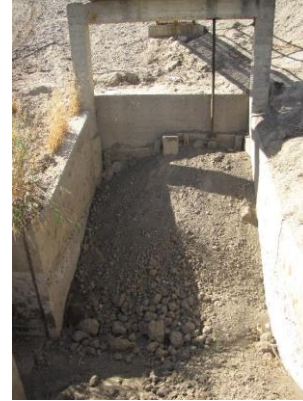
Photo 3 of 3 : UCIP_FA_2015_6295.jpg

Action/Comments					
Inspector Comments: FS_ID:44644 DS_ID:16427 EP_NO: 9482 FS_HLM: 7.14 Repair Type: Urgent Crossing Status: Found UCIP Comments: 4/20/2015 Same as last inspection. Structure is still buried. Structure is buried and non-operational. This crossing was listed in the USACE Periodic Inspection as ID# USACE_CESPK_MA1C_2010_p_0288 for sluice gate closed and backfilled on WS and full of sediment with wingwall cracked on LS. 7/18/2013 Same as last inspection. 12/17/2013 Same as last inspection. 6/23/2014 Same as last inspection. FIELD_STRUCT_DESC: 1 of 2: 36-inch concrete pipes through the levee. Wooden slide gates on waterward end. Concrete culvert through levee. Sliding metal gate noted in O&M manual. This entry could match the Drainage or Irrigation Structure referenced in the O&M manual (Station 370+90) (USACE-1955)(ABO No. 9482-1974, Elizabeth M. Farnsworth). FS Date: 04/22/2015

View of crossing from waterward side. Waterward side blocked by sediment. 2 slide gates part of structure design.

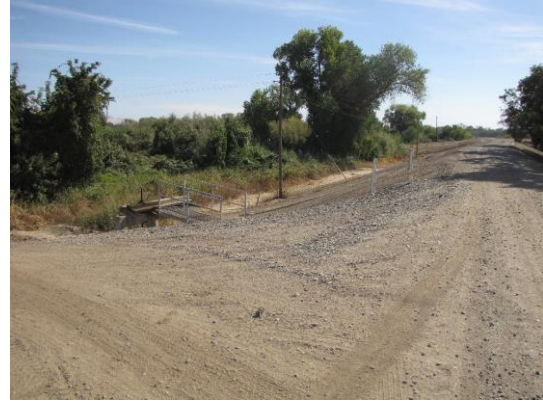
Photo 1 of 3 : UCIP_FA_2015_6296.jpg

UCIP Comments: 4/20/2015 Structure is operational. WS slide gate was unbrried aloowing water to irrigate the fields. It gets reburied during highwater season. Structure is buried and non-operational. This crossing was listed in the USACE Periodic Inspection as ID# USACE_CESPK_MA1C_2010_p_0288 for sluice gate closed and backfilled on WS and full of sediment with wingwall cracked on LS.7/18/2013 WS screw gate has been cleared of dirt and is open to irrigate LS fields. LS outlet is still mostly blocked by sediment.12/17/2013 WS screw gate was closed and buried by soil again6/23/2014 Same as last inspection. Soli dug out again and water flowing through crossing.

FIELD_STRUCT_DESC: 2 of 2: 36-inch concrete pipes through the levee. Wooden slide gates on waterward end. Concrete culvert through levee. Sliding metal gate noted in O&M manual. This entry could match the Drainage or Irrigation Structure referenced in the O&M manual (Station 370+90) (USACE-1955). (ABO No. 9482-1974, Elizabeth M. Farnsworth)
